Container inspection automation: a proof of concept

APIA conference, Strasbourg, July, 6th, 2023

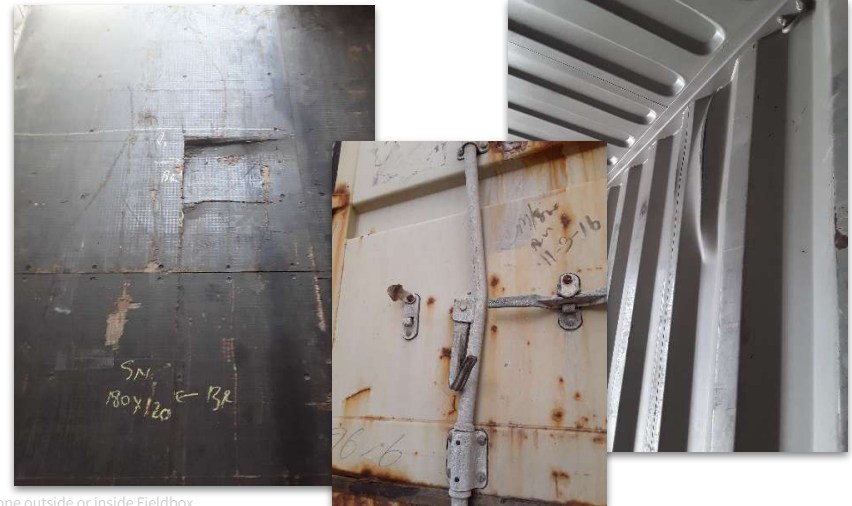
Inspection workflow

- Defects' pictures taken with a tablet
- Point of view: **really close** to the defect
- Multiple pictures taken per defect
- Repair recommendations proposed
- Defects are submitted to an ISO norm

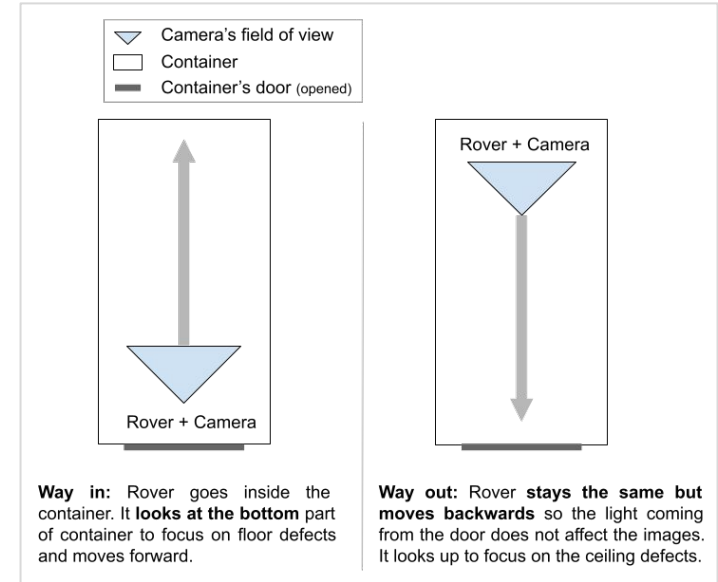
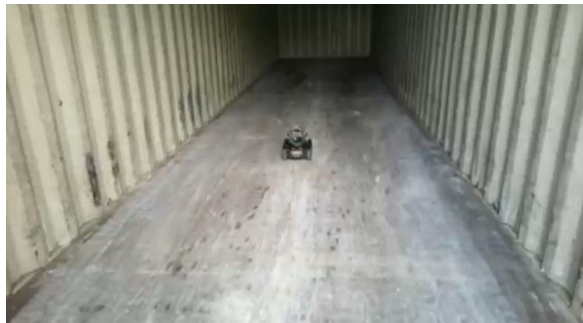
Hardware: rover for interior inspection

- We settled for a rover for interior inspection
 - With a 1080p camera
- Current workflow:
 - An operator opens the container's door
 - Puts the rover inside
 - Drives it according to a path we recommended
- Towards an automated workflow for a next project phase:
 - Sensors on the rover could have been a good option
 - **But:** they are not adapted to such a metallic structure
 - **TODO:** Hardcoding the rover's path thanks to the rovers's SDK

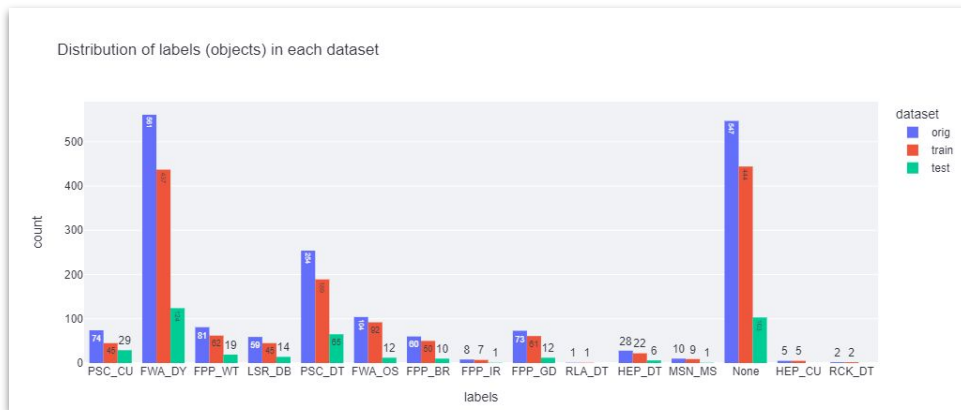
- Dataset was cautiously split into subsets so as to **avoid introducing unwanted bias**
 - 80% train (~ 1100 imgs) - 20% test (~ 260 imgs)
 - the training (sub)set is used for model training
 - the test (sub)set is used for model evaluation
 - Images from the same video are not split across different subsets
 - The original distribution of defects is preserved in all subsets (used: iterative stratified split for multi-label cases)
- The percentage of background images (i.e the no_defects class) was lower than 10%
- Data augmentation operations have been applied
 - vertical and horizontal flip
 - alteration of contrast and colors
 - image translation
 ⇒ ~ 500 images generated with data augmentation

Defects distribution in each data subset
